# PRECAST CONCRETE PLANT

Precast Concrete Plant – Septic & Sewage Units  
Precast/Prestressed  
Fairfield, Iowa, USA  
PENETRON ADMIX®

## CASE SUMMARY

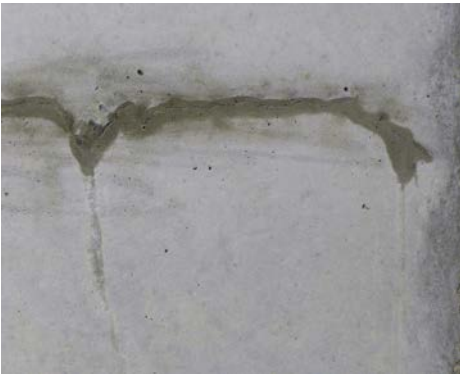
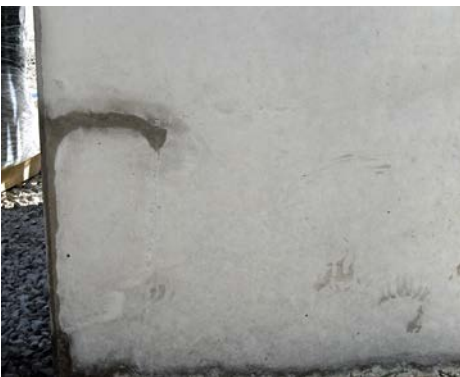
**DAY 1:**

**Leaks appear as the tank is filled**

Initially, while there was no noticeable drop in the water level, a number of leaks became apparent, showing themselves as continuous, dripping leaks. After three days the leaks had been reduced to a slow seepage with moisture creeping down the face of the tank 3-4 inches before evaporating. At this time, crystals were plainly visible as they began to fill in the cracks. After seven days, all leaks had stopped completely as crystal growth continued in the cracks, self-healing them until there was no moisture. The customer also noted the shrinkage cracks that were appearing in the precast concrete lids of these tanks had lessened through the use of PENETRON ADMIX.

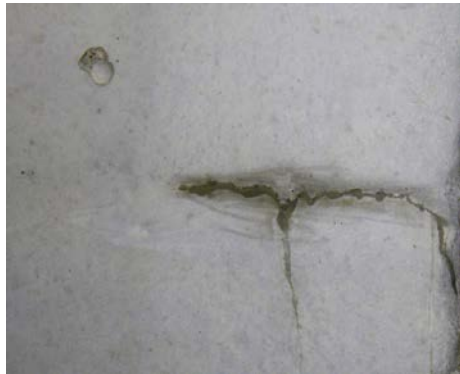
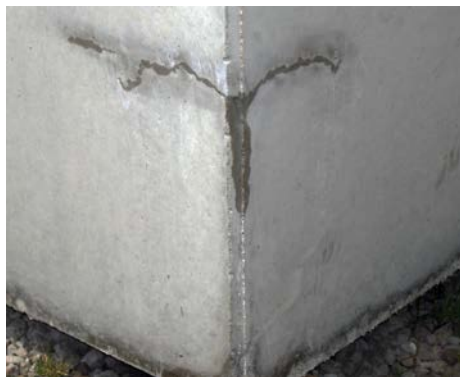
**DAY 3:**

**Crystals begin to grow filling the cracks**

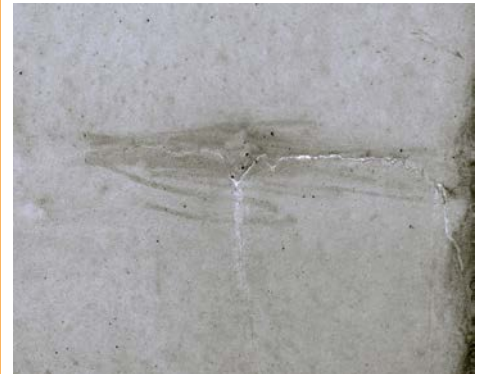
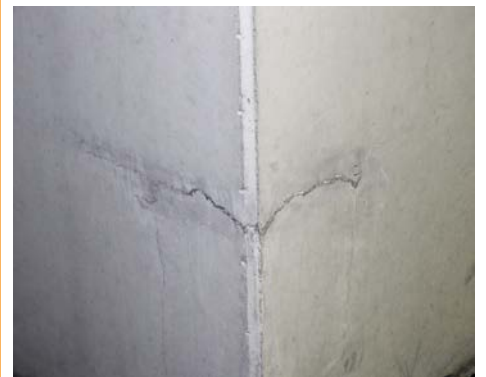
**DAY 7:**

**All cracks have self-healed and leaks have completely stopped**

**“After seven days all leaks had stopped completely.”**
